**DEPARTMENT OF TRANSPORTATION**

Contract #: 04-0120F4Cty: SF/ALA Rte: 80 PM: 13.2/13.9File #: 69.28**WELDING INSPECTION REPORT****Resident Engineer:**Pursell, Gary**Address:** 333 Burma Road**City:** Oakland, CA 94607**Report No:** WIR-009323**Date Inspected:** 16-Sep-2009**Project Name:** SAS Superstructure**OSM Arrival Time:** 1900**Prime Contractor:** American Bridge/Fluor Enterprises, a JV**OSM Departure Time:** 700**Contractor:** Zhenhua Port Machinery Company, Ltd (ZPMC), Changxing Island **Location:** Shanghai, China**CWI Name:** Xu Yumin, Li Hong Fei**CWI Present:** Yes No**Inspected CWI report:** Yes No N/A**Rod Oven in Use:** Yes No N/A**Electrode to specification:** Yes No N/A**Weld Procedures Followed:** Yes No N/A**Qualified Welders:** Yes No N/A**Verified Joint Fit-up:** Yes No N/A**Approved Drawings:** Yes No N/A**Approved WPS:** Yes No N/A**Delayed / Cancelled:** Yes No N/A**Bridge No:** 34-0006**Component:** Tower/OBG**Summary of Items Observed:**

### OBG SEGMENT-1AAE-1AE

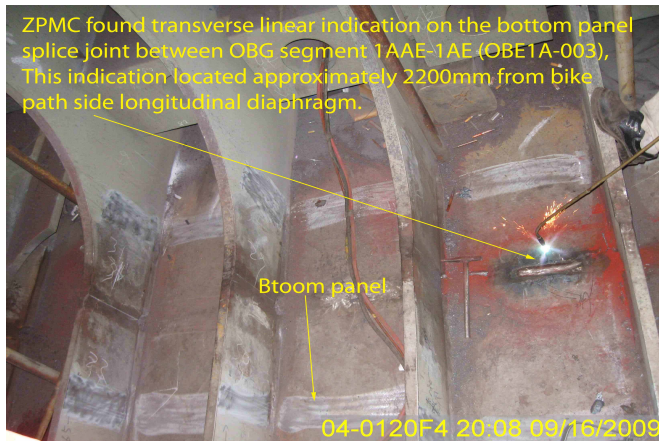
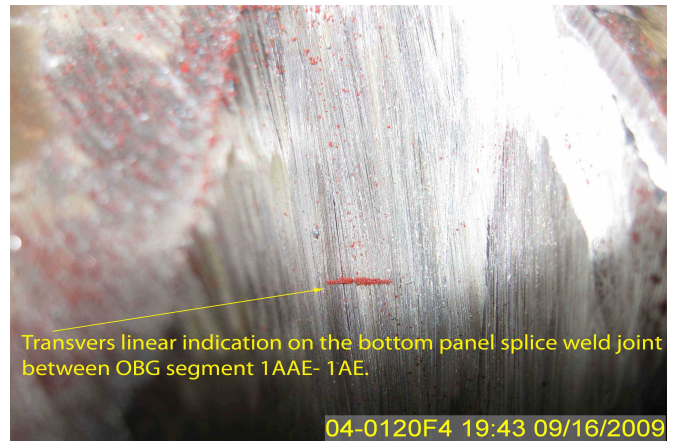
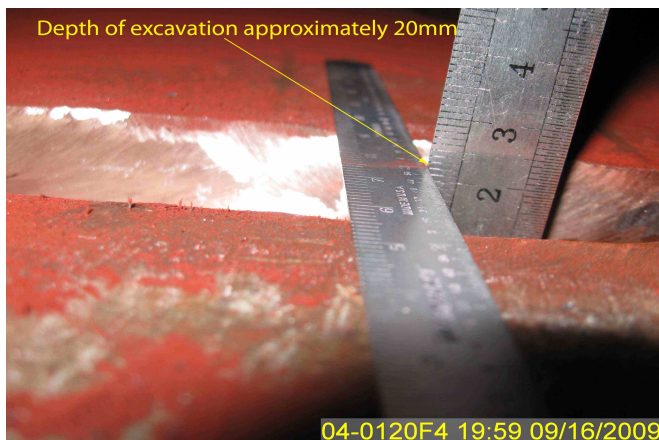
This Quality Assurance Inspector (QA) observed that the contractor excavated the bottom panel splice joint between OBG segments 1AAE- 1AE (OBE1A-003) at two locations. This excavations located approximately 2250 and 3000 from bike path side longitudinal diaphragm. The excavation measured approximately 200x40mm and 20mm in depth. This QA Inspector observed ZPMC NDT personnel performed Magnetic particle inspection over excavation area during the time of magnetic particle inspection this QA noted that ZPMC found a transverse linear indication approximately 10mm in length. This linear indication located approximately 2200mm from bike bath side longitudinal diaphragm. Regarding this issue informed to task leader and other supervisor. See the attached photos for additional information.
